RE: 131 Eliot Street, Milton, MA

This report documents our observations made on April 18 & April 20, 2012 during our visits to the referenced address.

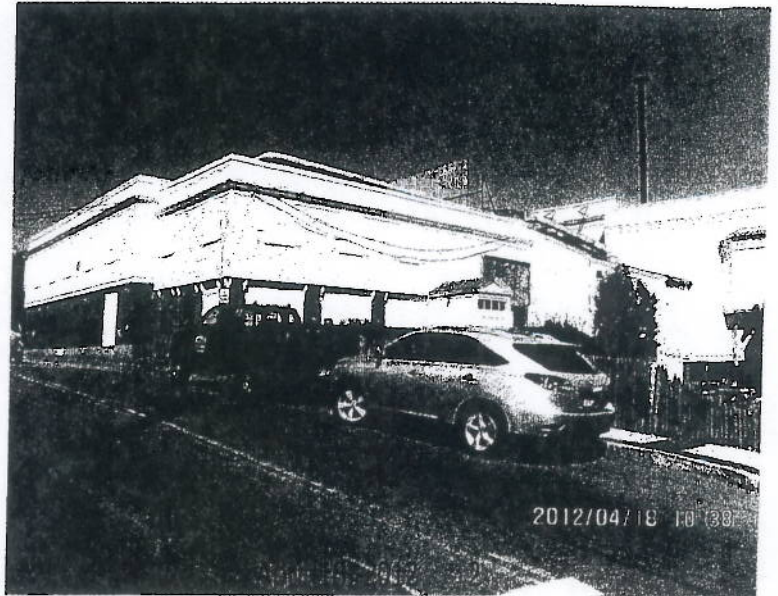
2A

We started by looking at the left portion of the building from Eliot Street and noticed that this is a partially brick, wood, and concrete building, which is two stories high. There is a brick façade which is partially covered with wood on the top. The brick façade on the second floor is covered with wood protruding outside of the façade. See picture #2A.

We understand your intent would be to remove the protruding wood portion of the building which does not appear to be structural.

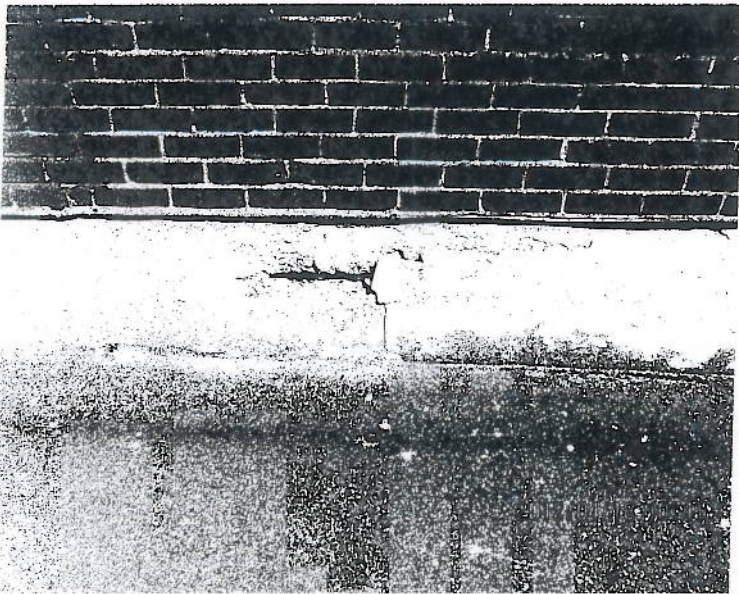
3A

Some partial repointing will be needed on the bricks. There is also some repair of the concrete needed at the base. See picture #3A showing the rebar.

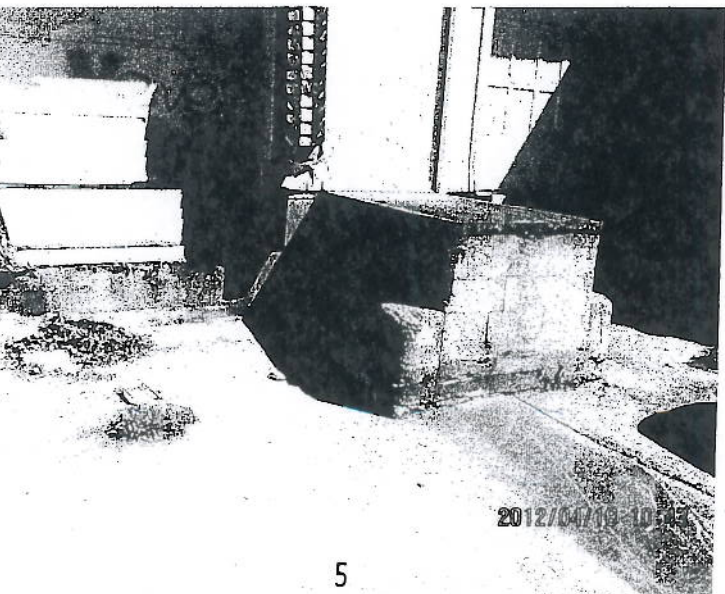
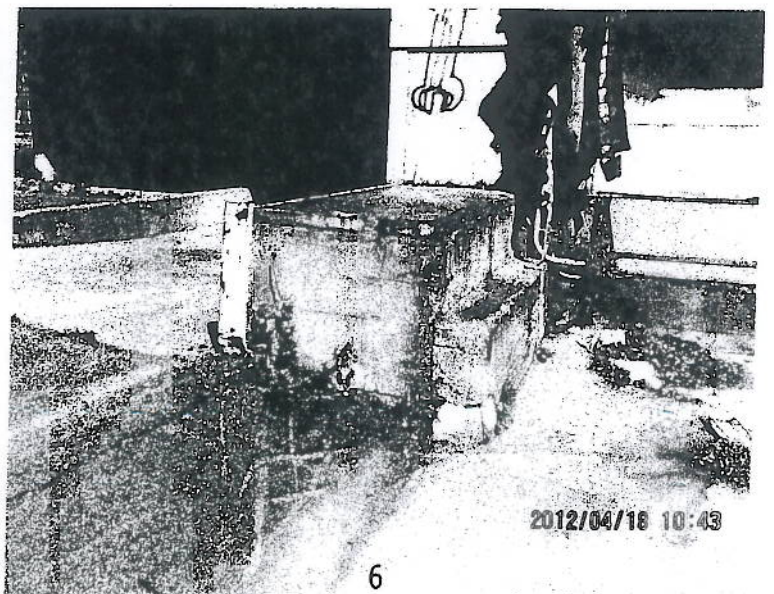
Walking more to the left of Eliot Street at the end of the building we noticed a loading dock. There is some necessary work to be done on the concrete. See pictures #5A and 6A.

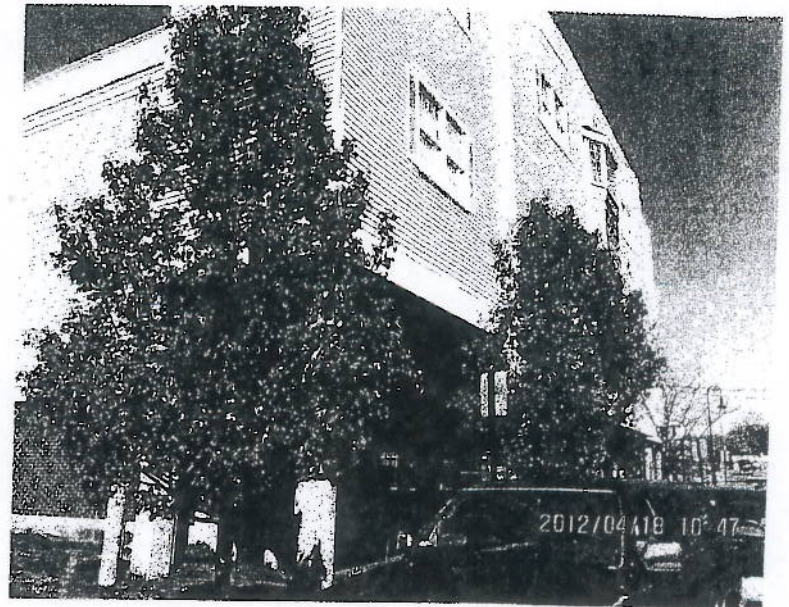
8A

We then proceeded to look at the elevation on Central Street. See picture #8 showing the concrete column in the front.

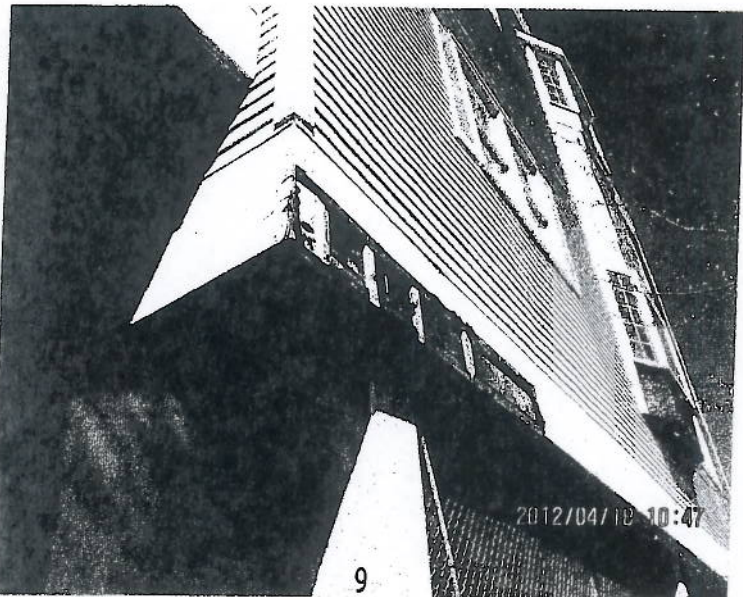
9
9A

We could see that the wood façade above has been damaged by water. See picture #9A. We did not have access to the parking lot underneath which is built of concrete columns and concrete beams. See next visit below.

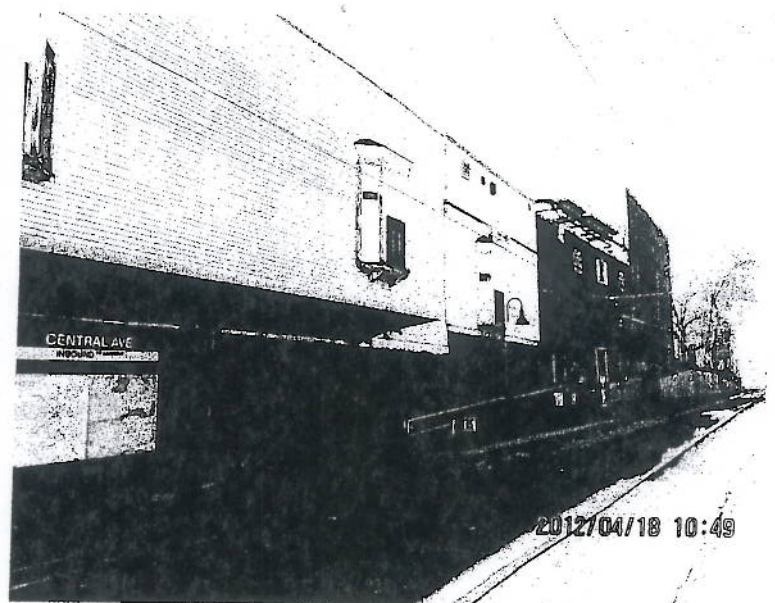
10A

There is a very long façade facing the railway. See picture #10A.

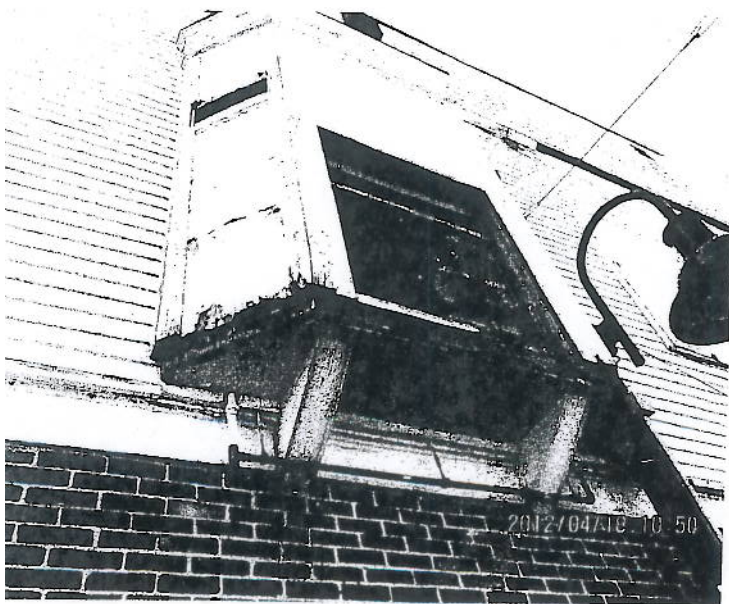
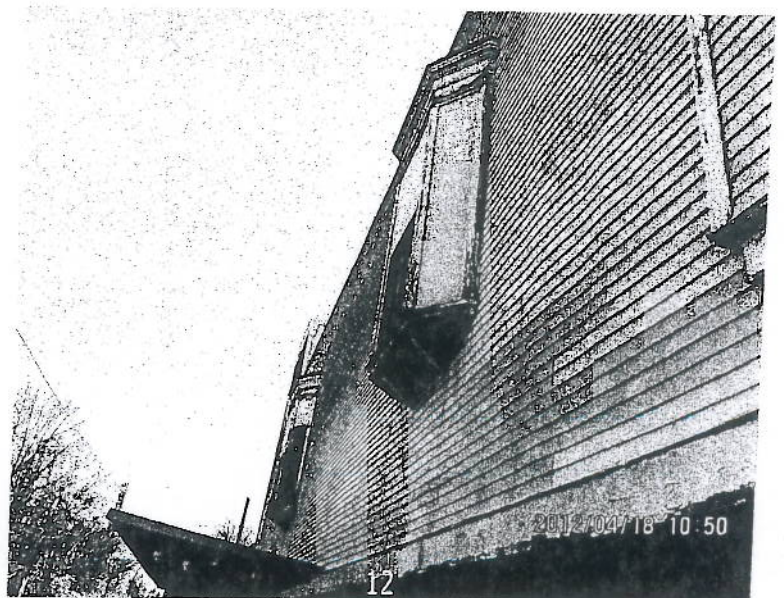
Bay windows are protruding from the façade. These bay windows are in very bad condition as one could see on pictures #11 and 12.

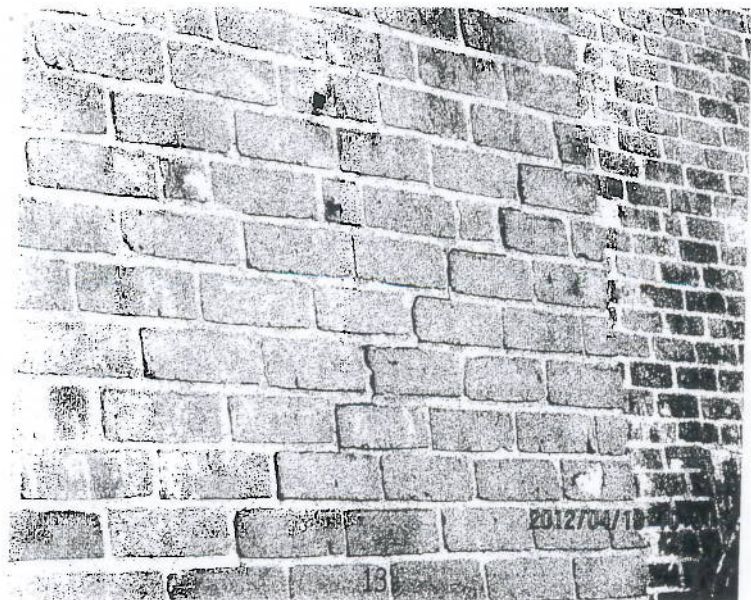
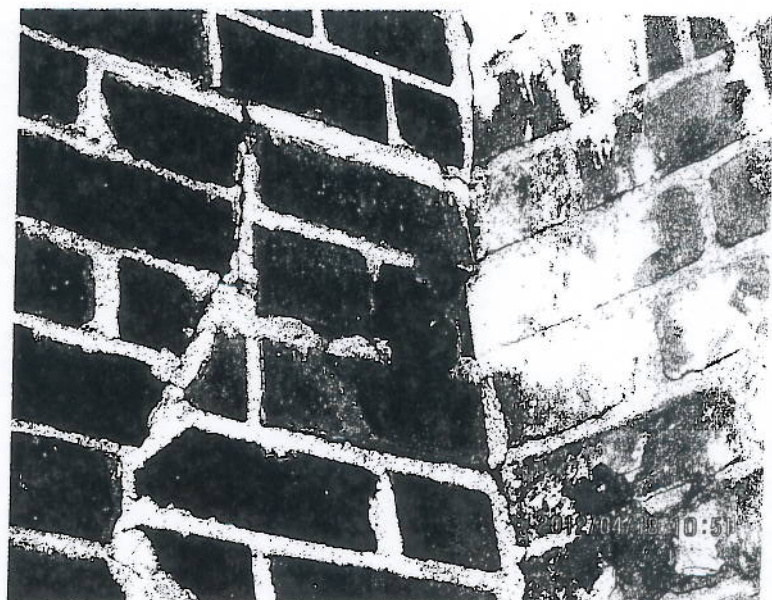
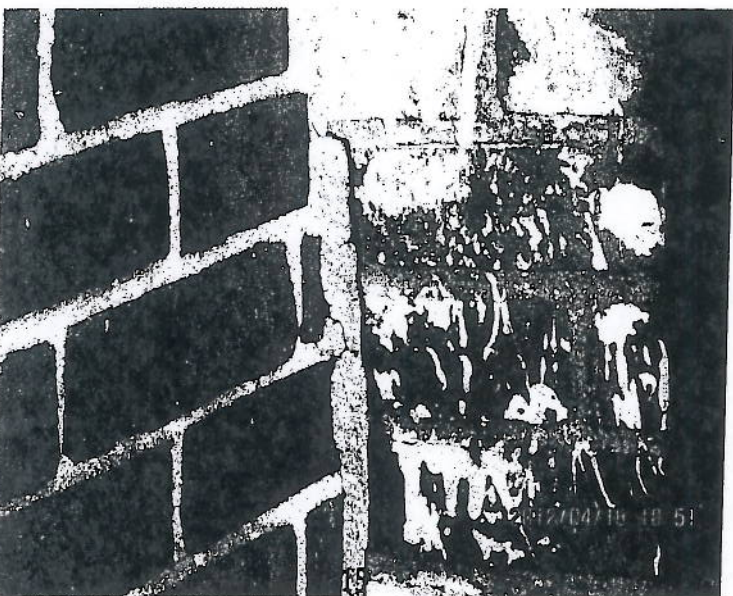
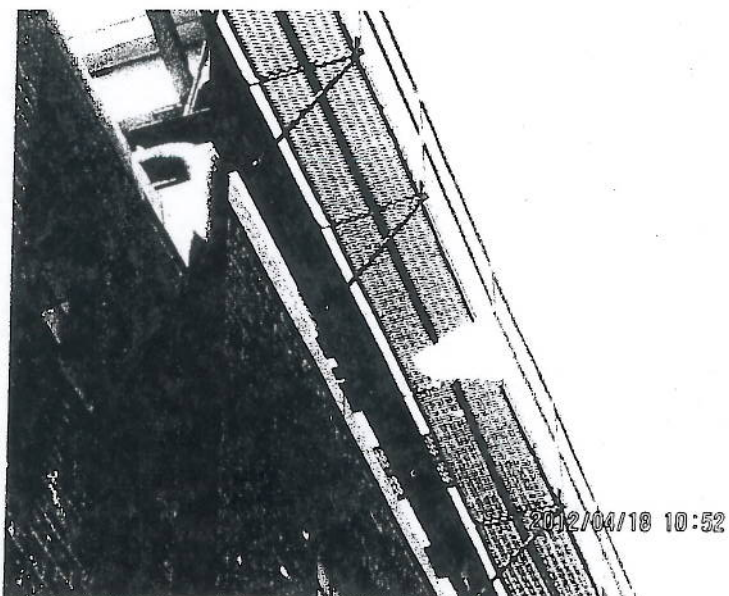
The brick façade will need to be carefully evaluated and repaired as one could see some signs of cracks, spalling, deep repointing, etc. See pictures #13A through 16A.

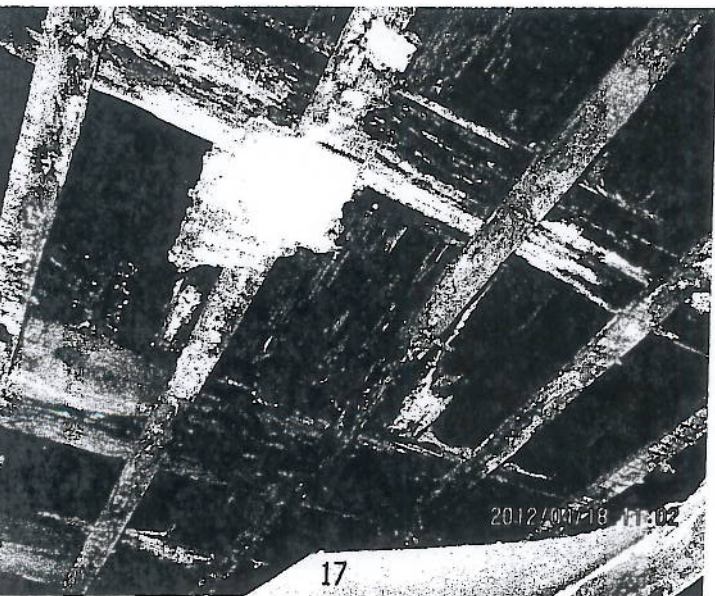
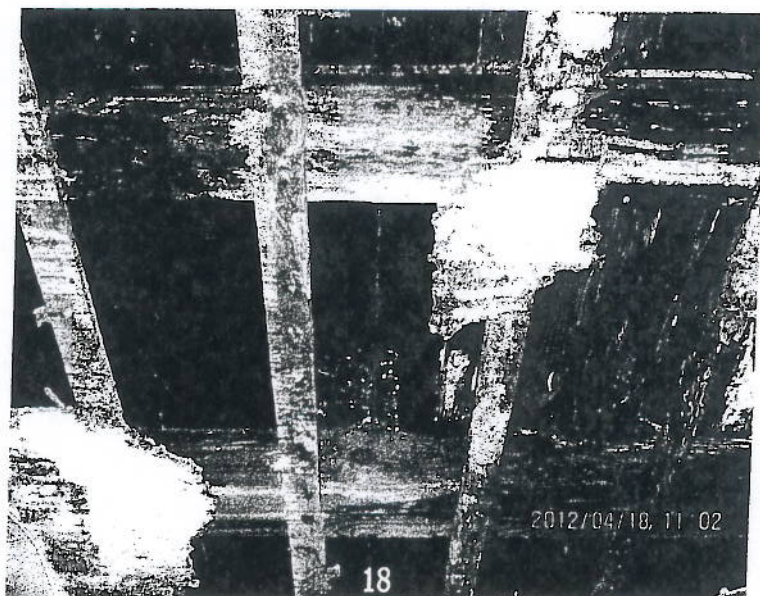
We proceeded to the right side of the building, but toward the left in a few areas which were exposed, we noticed some bad mold (see pictures #17A and 18A) and rot damage on the structure above as one could see on the pictures.

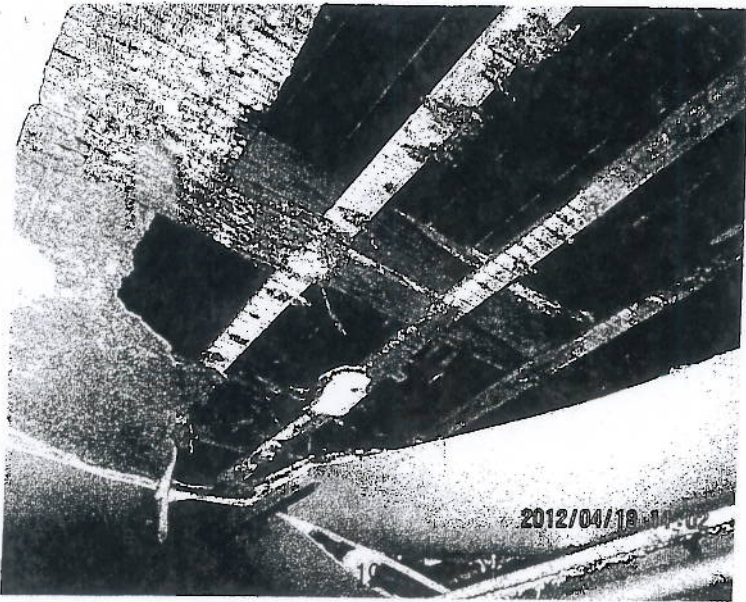
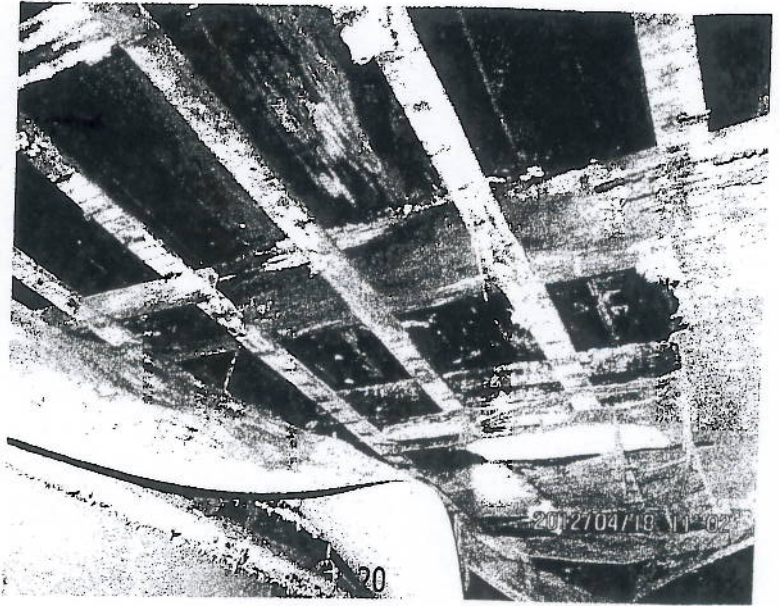
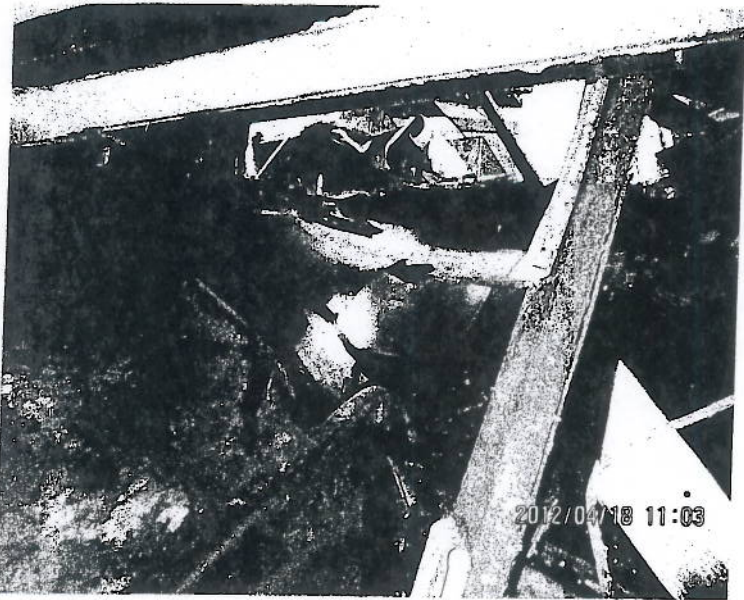
We then started to look at the area where the wood structure starts on the floor above. There one could see that the situation has triggered some collapses and most of the wood structure would have to be completely removed. See pictures #19A through 21A.

Whatever wood structure remains, it would have to be properly shored during that time unless one elects to remove the entire wood structure.

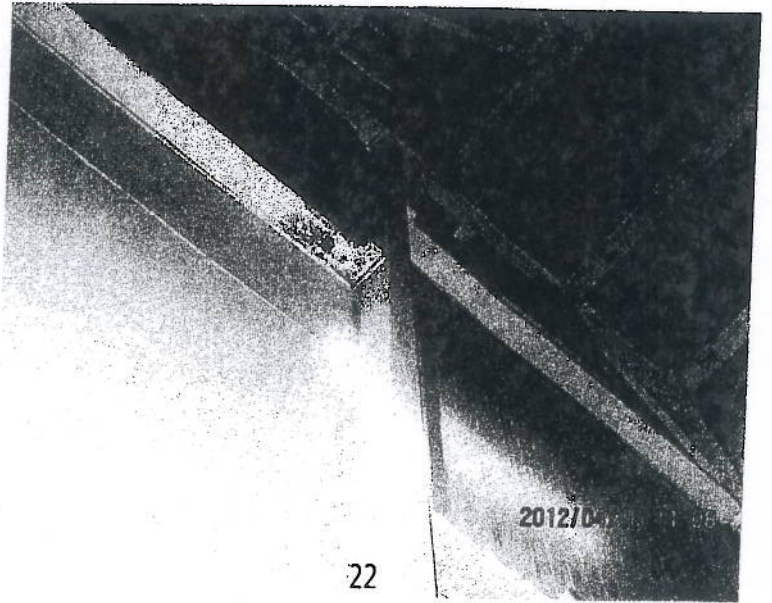
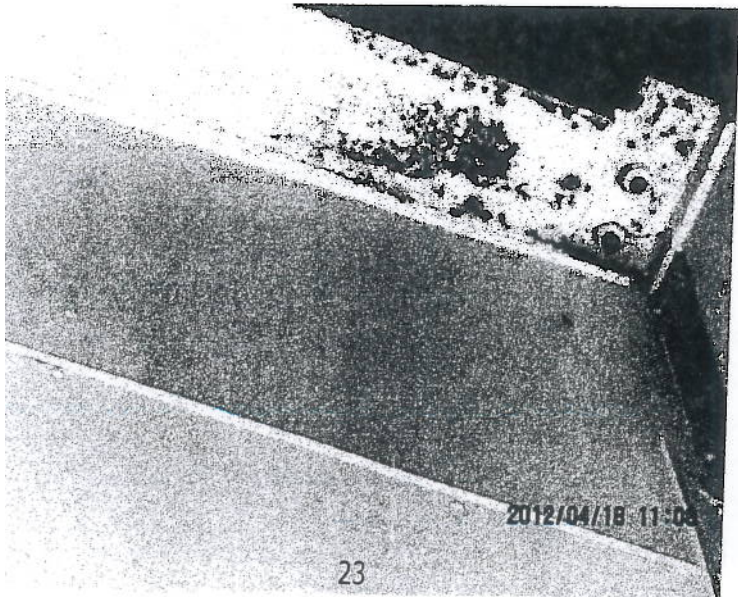
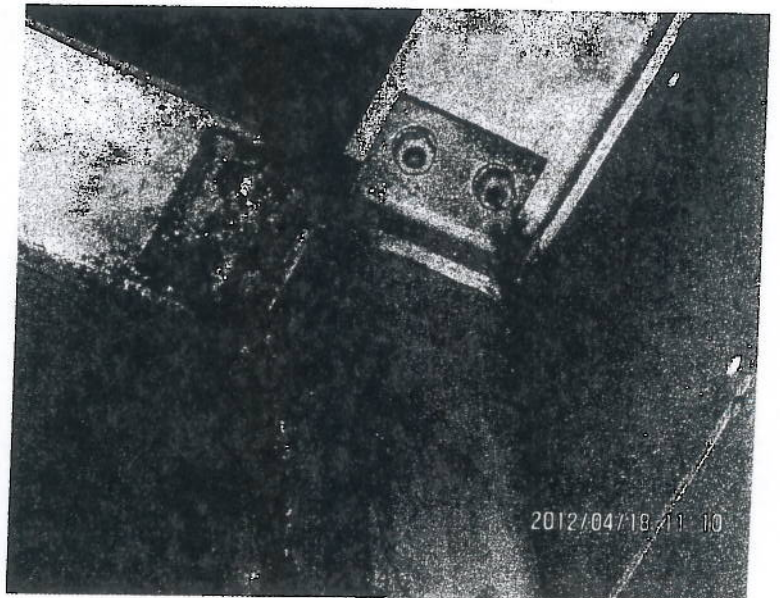
The steel portion of the building appears to be in relatively good condition, but rust has started to damage the bolts, and the beams will need to be wire brushed to

white steel and repainted. Rusted bolts will need to be replaced. See pictures #22A through 24A.

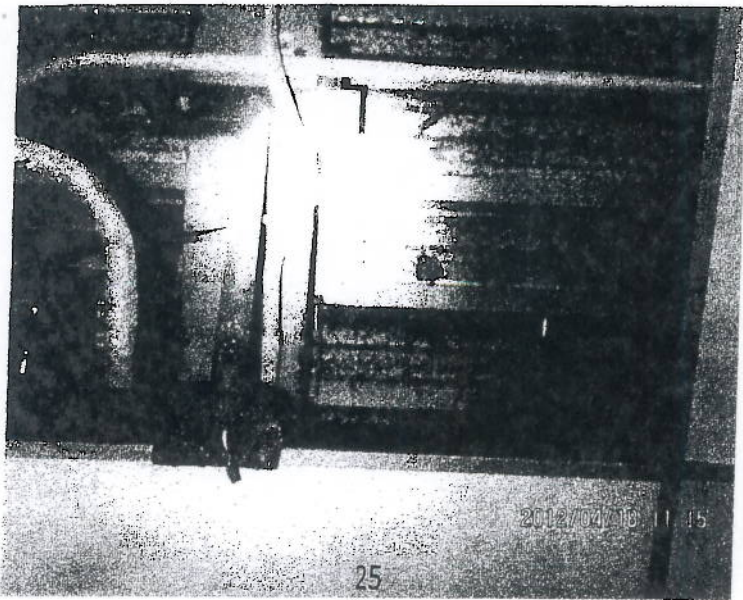
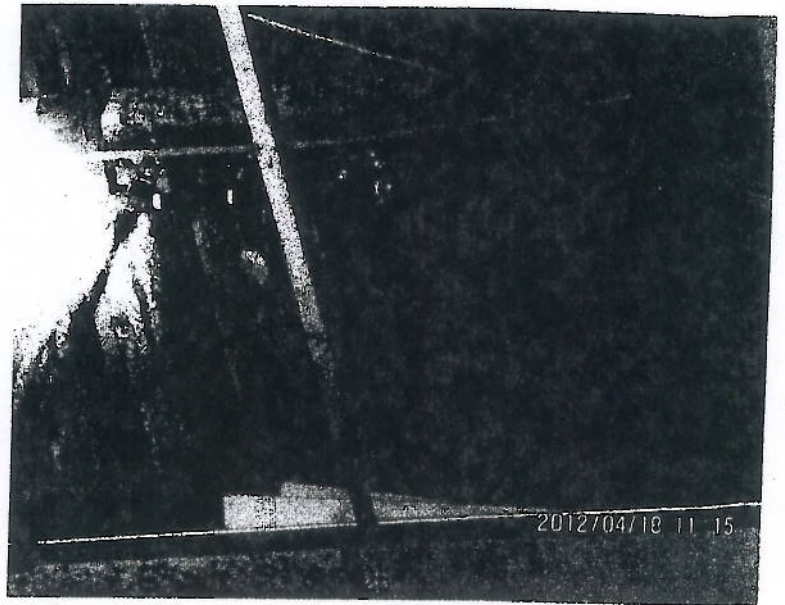
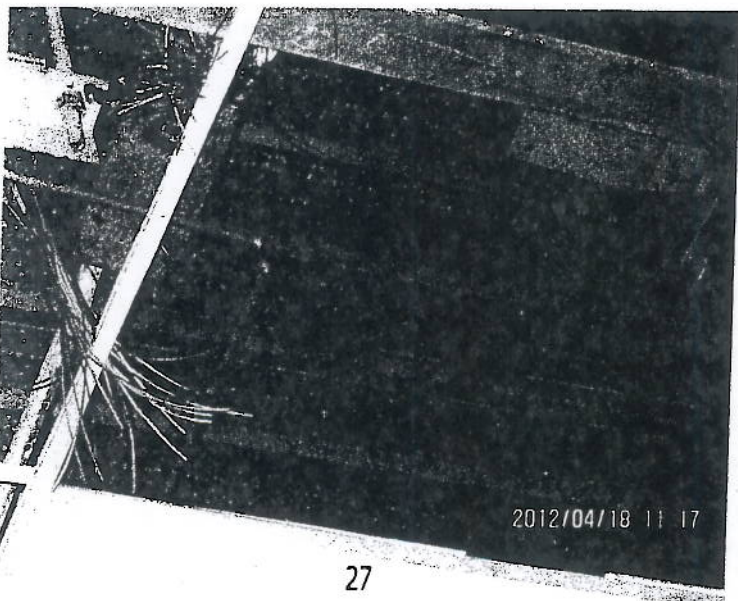
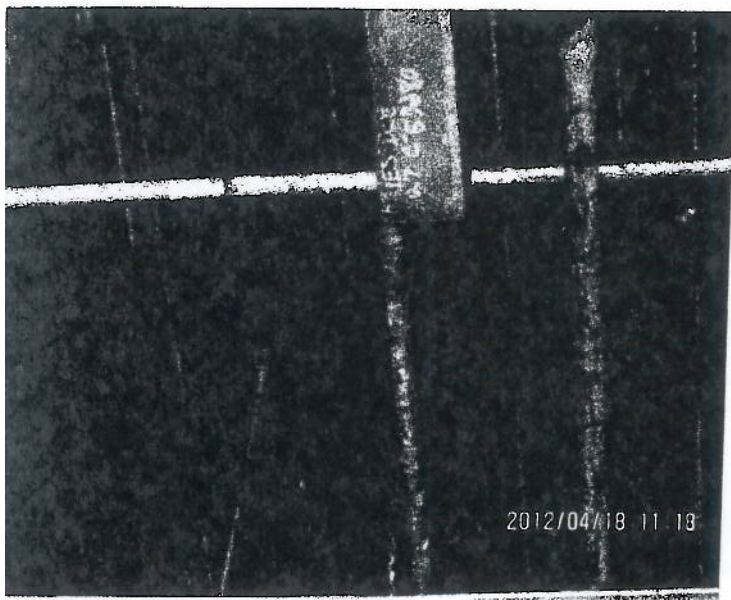
As we proceeded slightly from the right to the left, we noticed the next section where the roof was much lower. There again, across the drop ceiling one could see some rust and steel decks. At this time we can see that some of it is badly to slightly rusted. See pictures #25A through 29A of the rusted deck. The deck will have to be verified after wire brushing and drilling through the areas which are rusted the worst where they have lost too much thickness. Some of the sections will need to be replaced.

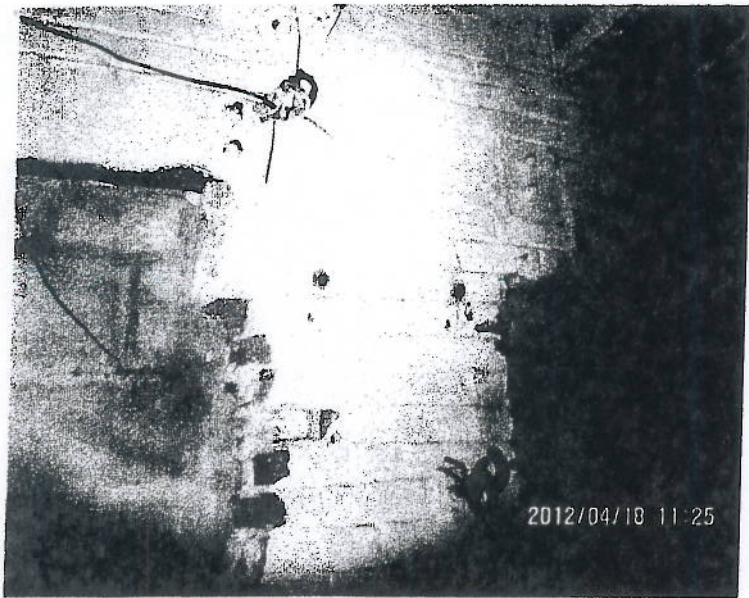
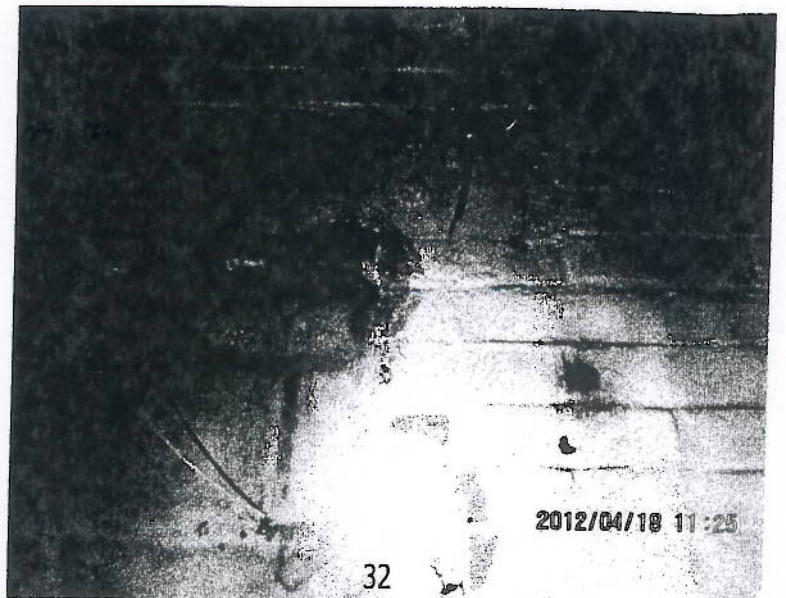
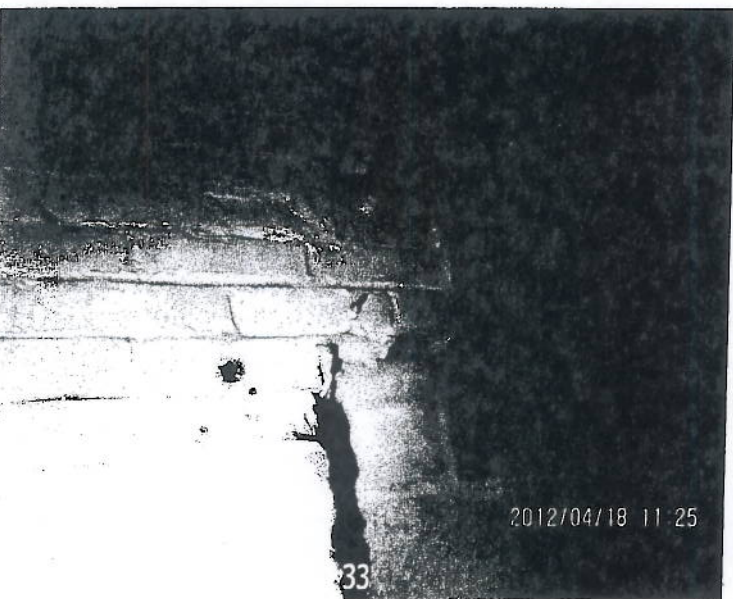
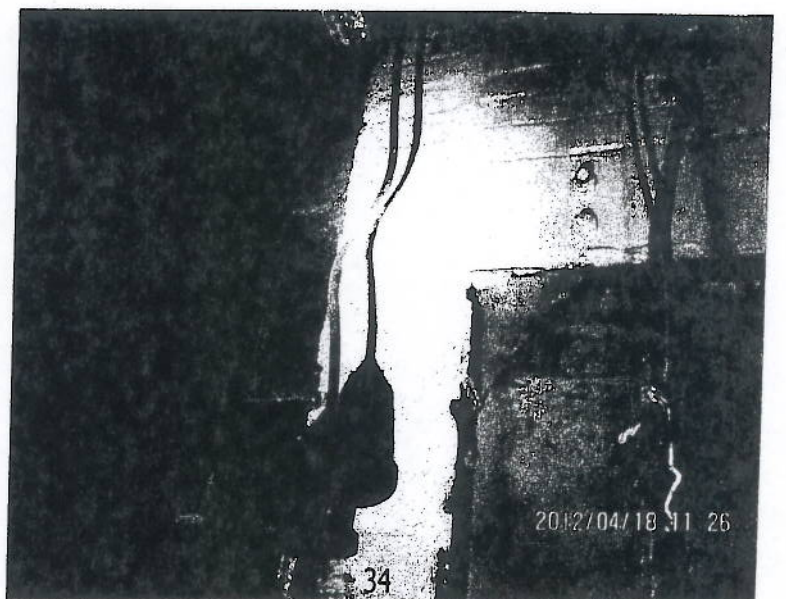
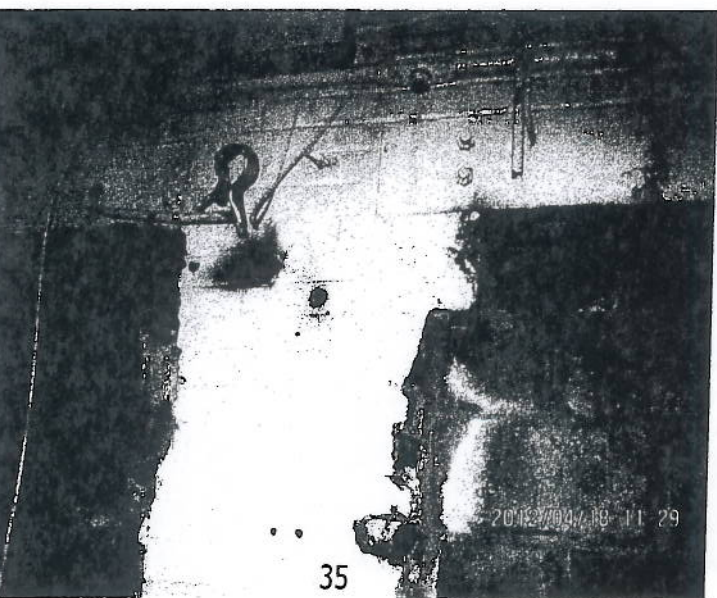
As we looked at the back of the building facing the train tracks, we noticed some important windows which were partially in filled toward the exterior. Unfortunately, upon doing this, the existing lintels were improperly supported. Some structure will be necessary to either reinforce a pier to the original capacity or to reinforce the infill to make it work as a bearing wall. See pictures #31A through 35A.

The improper piers are only the piers between columns.

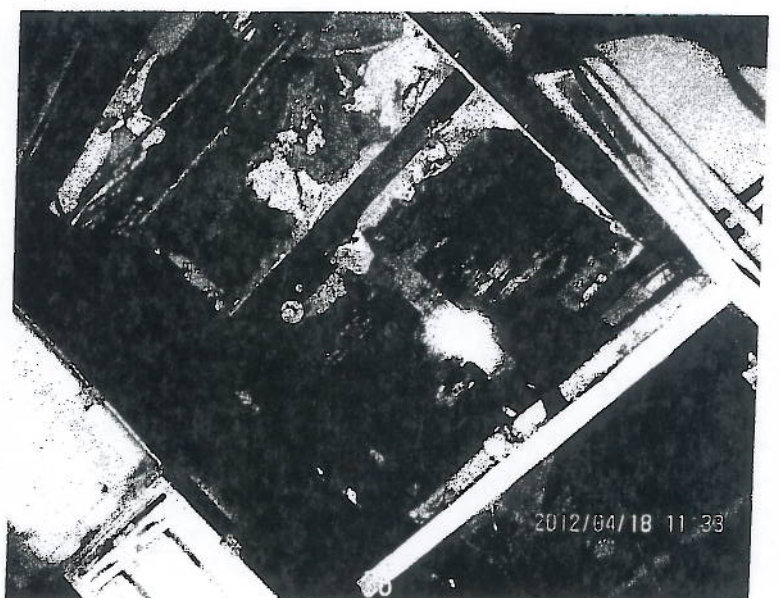
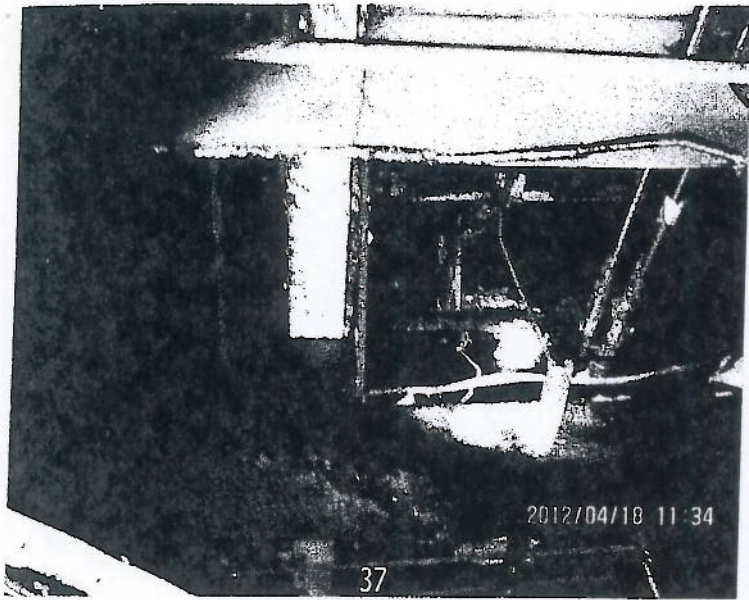
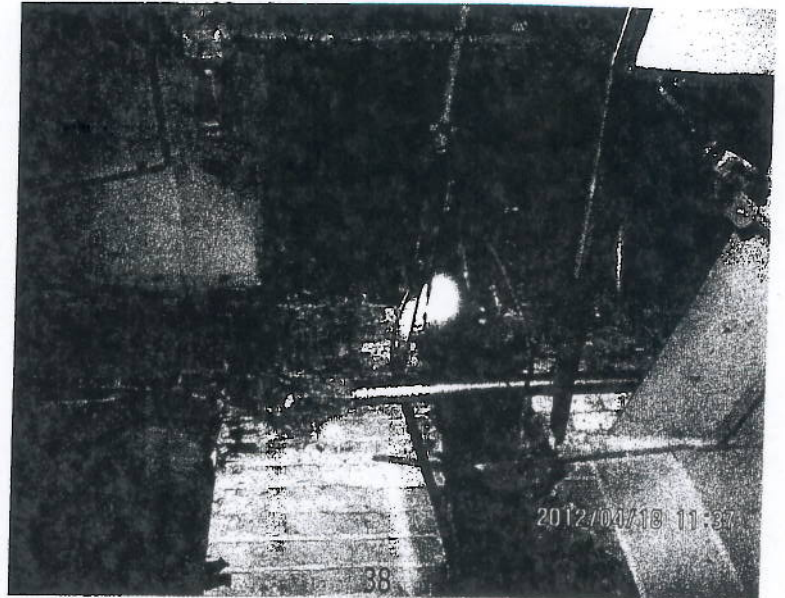
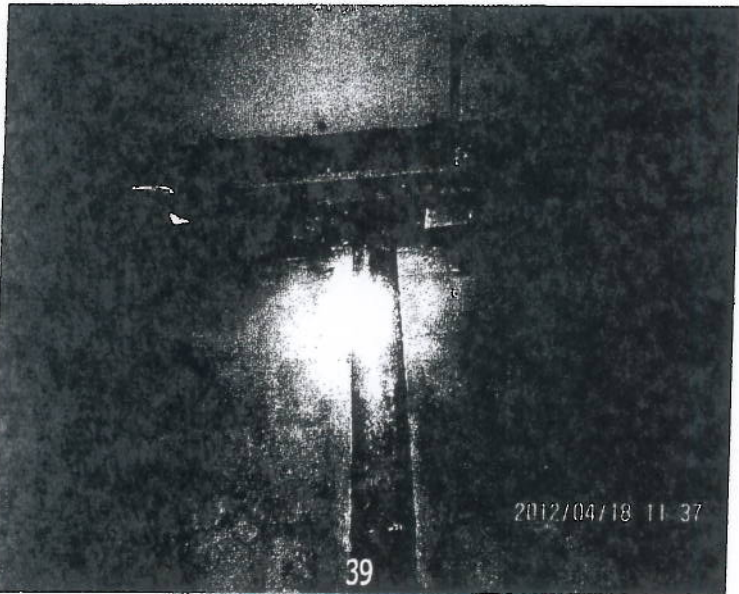
As we proceeded toward the very back wall of the building, we noticed that the steel in the wall was in bad condition having a substantial amount of rust which needs to be properly assessed. The wood above needs to be removed. See pictures #36A through 39A.
